Manhole Inspection Summary

Manhole # S13EE2018MH

Insp Date: **9/28/06 12:52 PM**

Location Address: **5800 CREST RD**

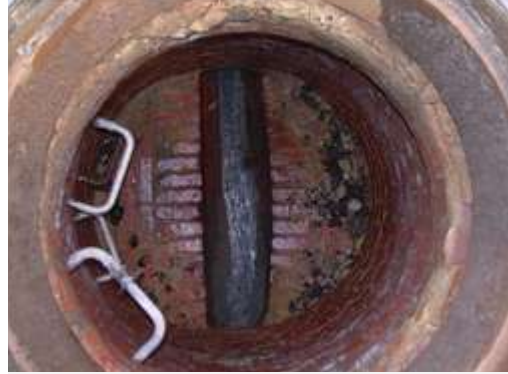
Top View

Corroded step. Bench debris.

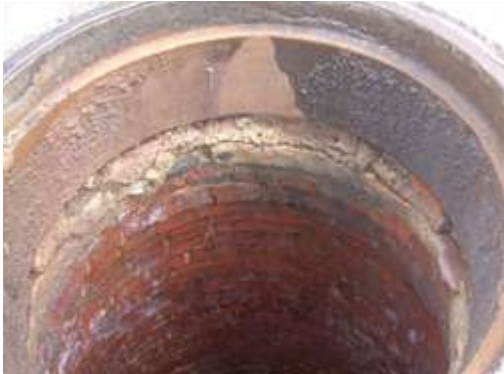
Defect

Frame leaks. Adjustment deterioration, loose brick, and infiltration. Corbel and Barrel infiltration.

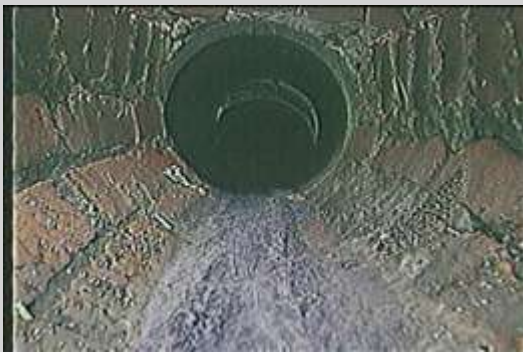
8 in. Circular Gravity Sewer Pipe Out @ 12 O'Clock

Comments **Both pipe pictures show Channel deterioration.**

Channel deterioration.

Infiltration: **Evidence** Pipe Seal Cond: **Cracked**

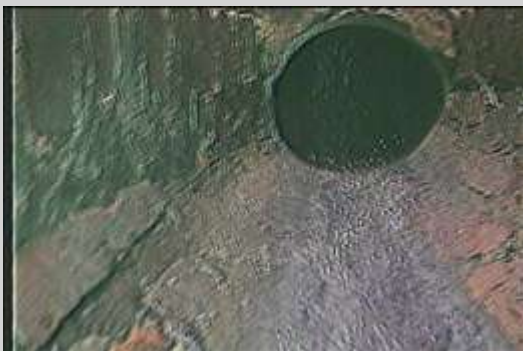
8 in. Circular Gravity Sewer Pipe In @ 6 O'Clock

Channel deterioration.

Infiltration: **Evidence** Pipe Seal Cond: **Unknown**
